RED HILL REPAIR TANKS OPTIONS STUDY

FISC Pearl Harbor, Hawaii

Final Report

EEI Project 08-4942

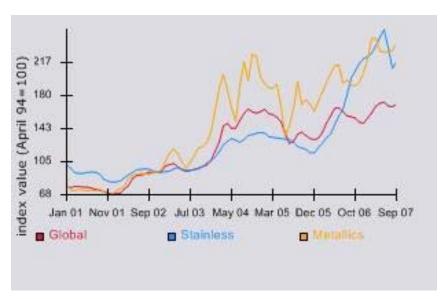
CRU data indicates an increase of over 300% in steel prices from 2001 to 2007.

A recent Wall Street Journal article dated July 16, 2007 states "The price of a ton of hot-rolled steel, a benchmark base product used in most finished steel, currently stands at around \$575 on the spot market--well above the \$175 the same ton of steel cost on the spot market back in 2001." This equates to approximately 325% cost increase in six years.
